Monitoring Cruise at the Morris Cove Borrow Pit

# Disposal Area Monitoring System DAMOS

Contribution 129  
June 2001

**Contract No.**  
DACW33-00-D-0001  
**SAIC Report No. 520**

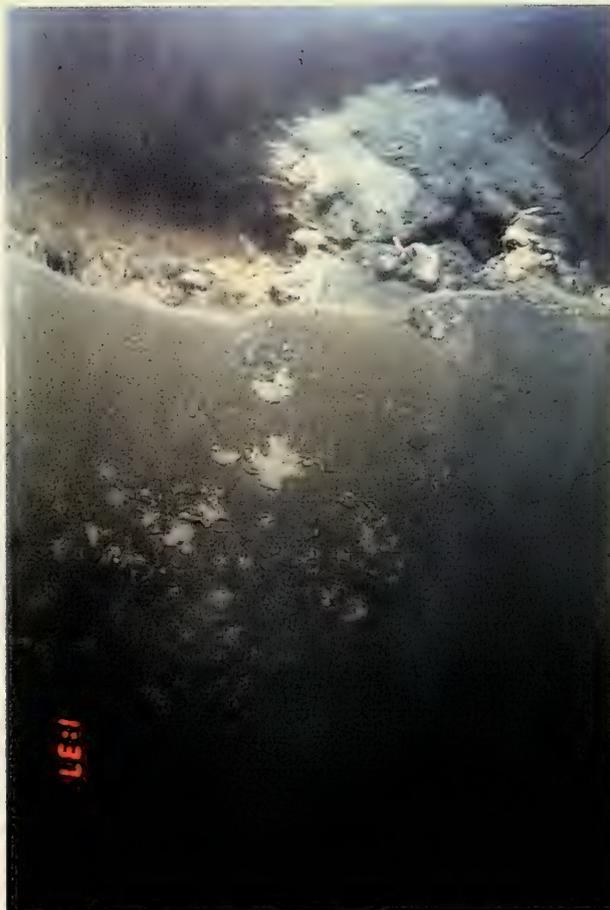
**Figure 3-4.** REMOTS® image from station 100SW within the Morris Cove borrow pit, showing a layer of fine-grained dredged material extending from the sediment-water interface to below the imaging depth of the camera (i.e., dredged material greater than penetration). A clump of cohesive clay measuring 7 cm in diameter is visible on the sediment surface, resulting in increased small-scale boundary roughness. Numerous Stage I polychaete tubes protrude from the clay clump, and a dense Ampeliscid amphipod tube mat (Stage II) is visible on the left side of image.

The average boundary roughness value for the borrow pit stations was 2.33 cm, indicating a moderate amount of small-scale surface relief (Table 3-1). The irregular and/or sloping small-scale topography observed at many stations was deemed to be physical in nature, due to the presence of cohesive clay clumps resulting from the dredging and subsequent disposal operations (Figure 3-4). There was no obvious spatial pattern in the boundary roughness values across the surveyed area. A single occurrence of biogenic surface roughness was due to the presence of a dense mat of tubicolous amphipods (*Ampelisca* sp; see Figure 3-4) at station 25NE. Shells and shell hash were observed at the sediment surface at several stations.

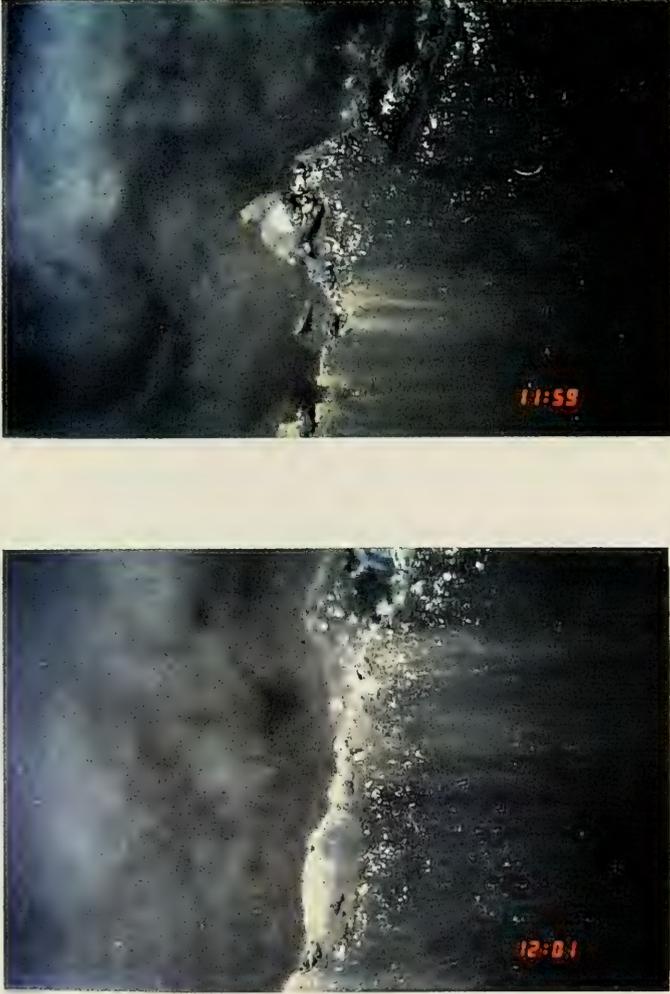
**Figure 3-5.** REMOTS® images from stations REF4 (left) and REF5 (right) illustrating the relatively soft, fine-grained sediment (grain size major mode of  $>4$  phi) which characterized the reference area stations. Both images show a surface shell lag deposit, irregular topography, and an exceptionally thin RPD layer, possibly due to periodic scouring of the sediment surface by currents/waves.

Sediments at the reference area stations were similar to those within the borrow pit in being predominantly fine-grained (major modal grain size of  $>4$ ; Table 3-2 and Figure 3-5). Dredged material was not observed in any of the images at the reference area stations. Mean camera penetration depths ranged from 10.76 cm at Station REF4 to 14.06 cm at Station REF1, with an overall average of 13 cm (Table 3-2). This is moderately deep penetration, comparable to that at the borrow pit stations, which is considered typical for the soft, fine-grained ambient sediment present at the reference areas.
